**CITY OF PRESCOTT  
MEETING NOTICE  
PUBLIC WORKS COMMITTEE  
MONDAY, JULY 25, 2016  
AT 5:30 P.M.  
PRESCOTT MUNICIPAL BUILDING  
800 BORNER ST.  
PRESCOTT, WI 54021  
Website: prescottwi.org**

CITY OF PRESCOTT, WISCONSIN

JUNE 27, 2016 PUBLIC WORKS COMMITTEE

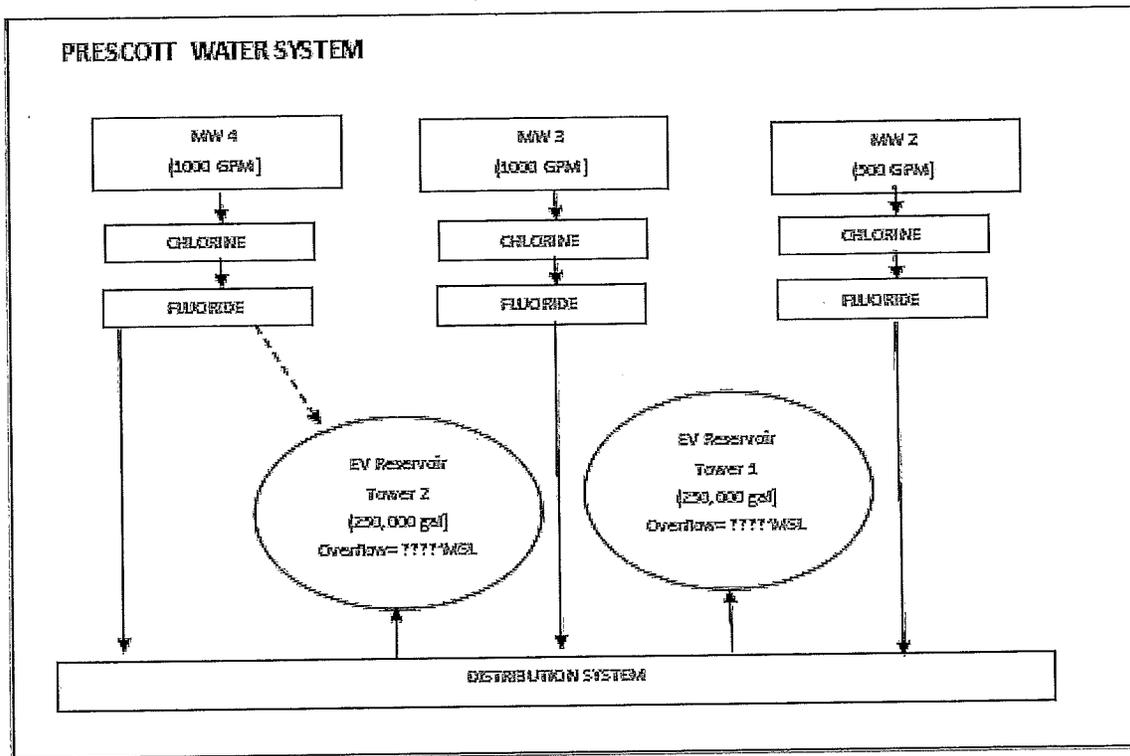
Prescott is mid-sized community water system. A plant flow diagram is seen below.
